ITALIAN MARITIME INVESTIGATIVE BODY ON MARINE ACCIDENTS

MARINE ACCIDENT
INVESTIGATION
C/S COSTA CONCORDIA
13th January 2012

*MSC90
London - May 18th, 2012*

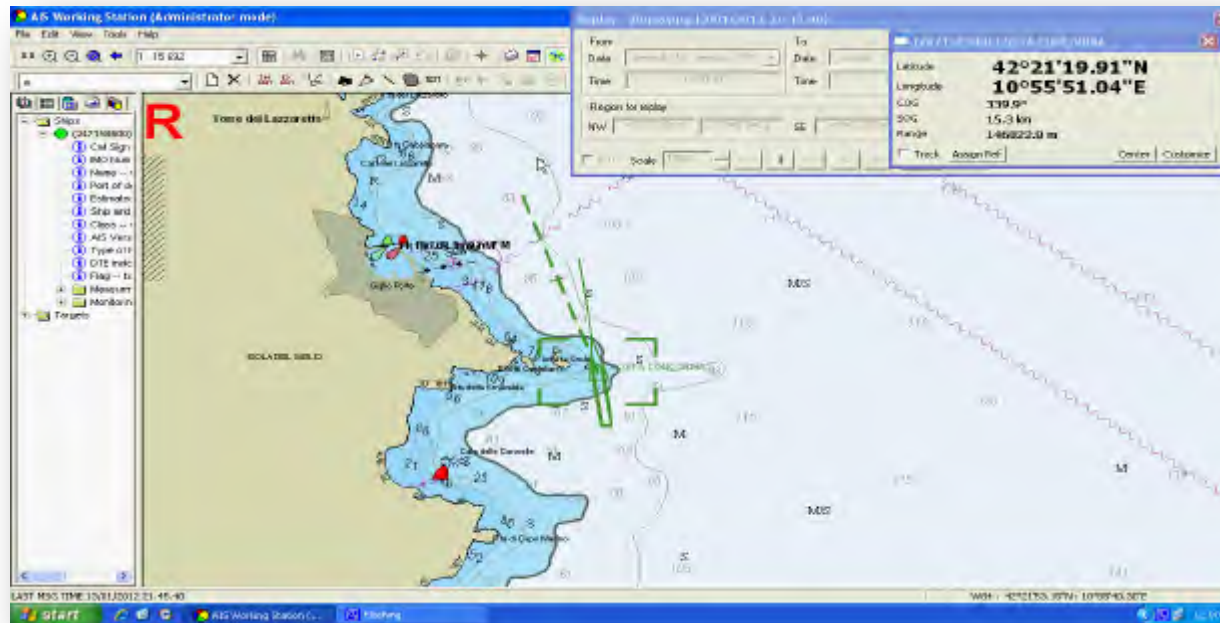
- 1) "hard to starboard" and the Ship's bow avoids the shallows;
- 2) "hard to port", but the Ship's stern cannot avoid them

09.45 pm : COLLISION between the port side of the hull and the eastern rock of "Le Scole"

- 3) "hard to starboard" and the ship speed reduces instantly up to 8,3 knots, drifting off in headway, on a heading of 350°

IMMEDIATELY the two Ship's main electrical engines lose power

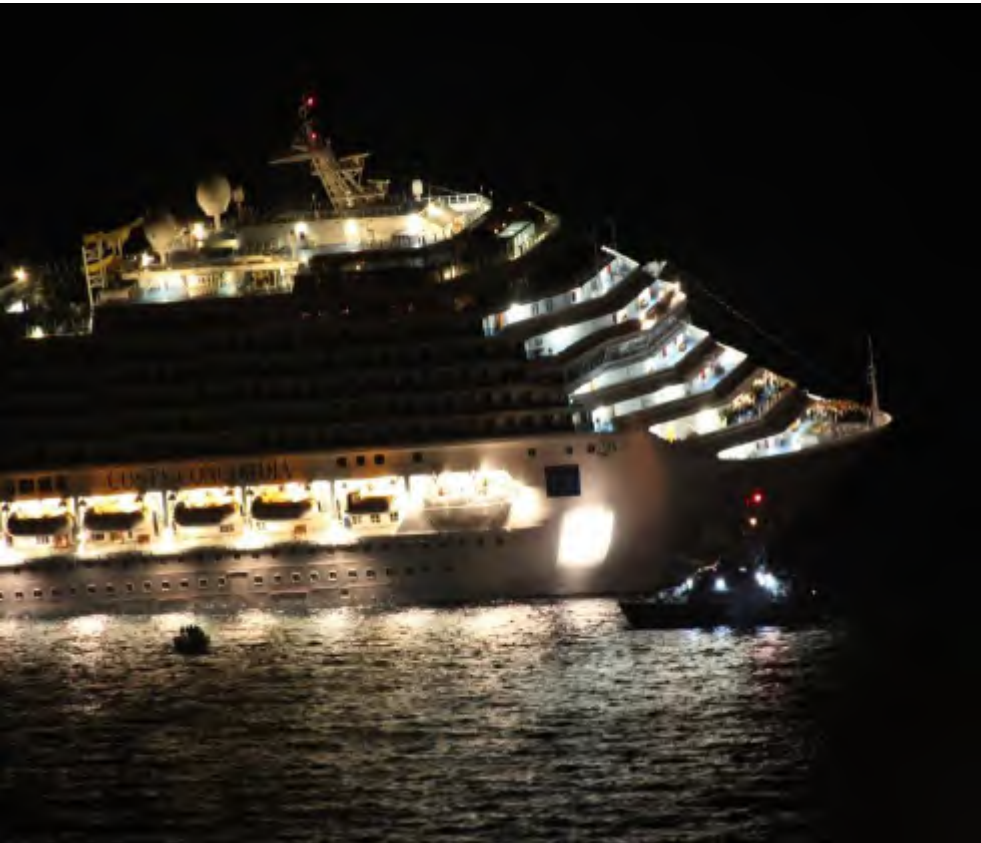
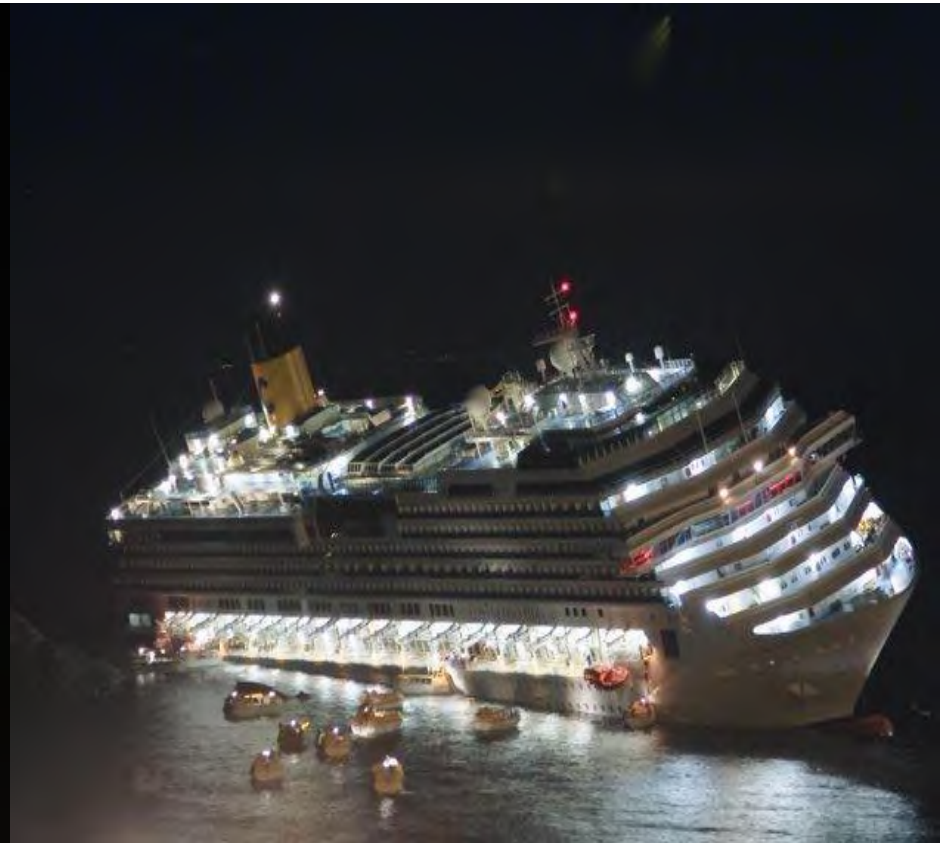
*The pictures were taken from the Island of Giglio
the image does not correspond to the present history of events, but it is noteworthy for showing the exact
moment when the lifeboats are launched on the starboard side*

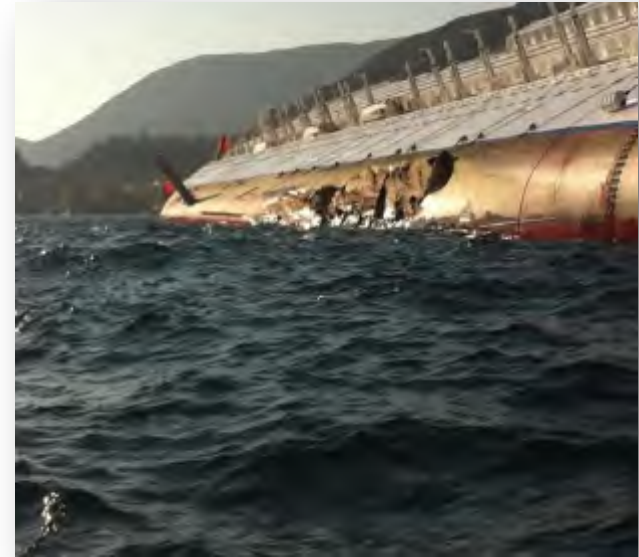
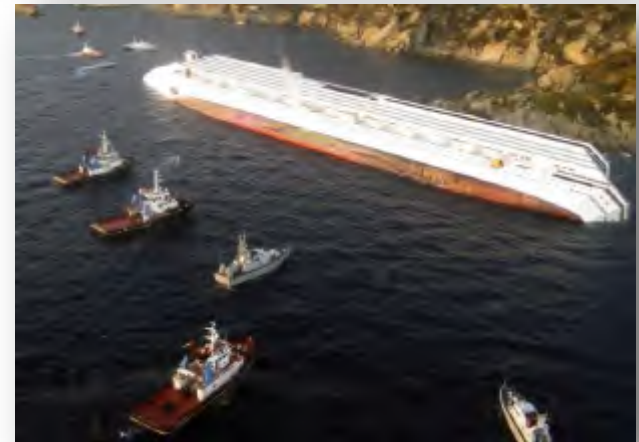
**Damage between frame no. 58 and frame no. 125/128,
creating a 60 meters hole into the hull – portside**

- The two most affected watertight compartments (contiguous), immediately flooded:
 - no. 5 (Propulsion Electric Motor)
 - no. 6 (aft generators)
- Partially flooded at the time of crew inspection (10 minutes after the impact)
 - no. 7 (forward generators)
 - no. 4 (Galley compressors)

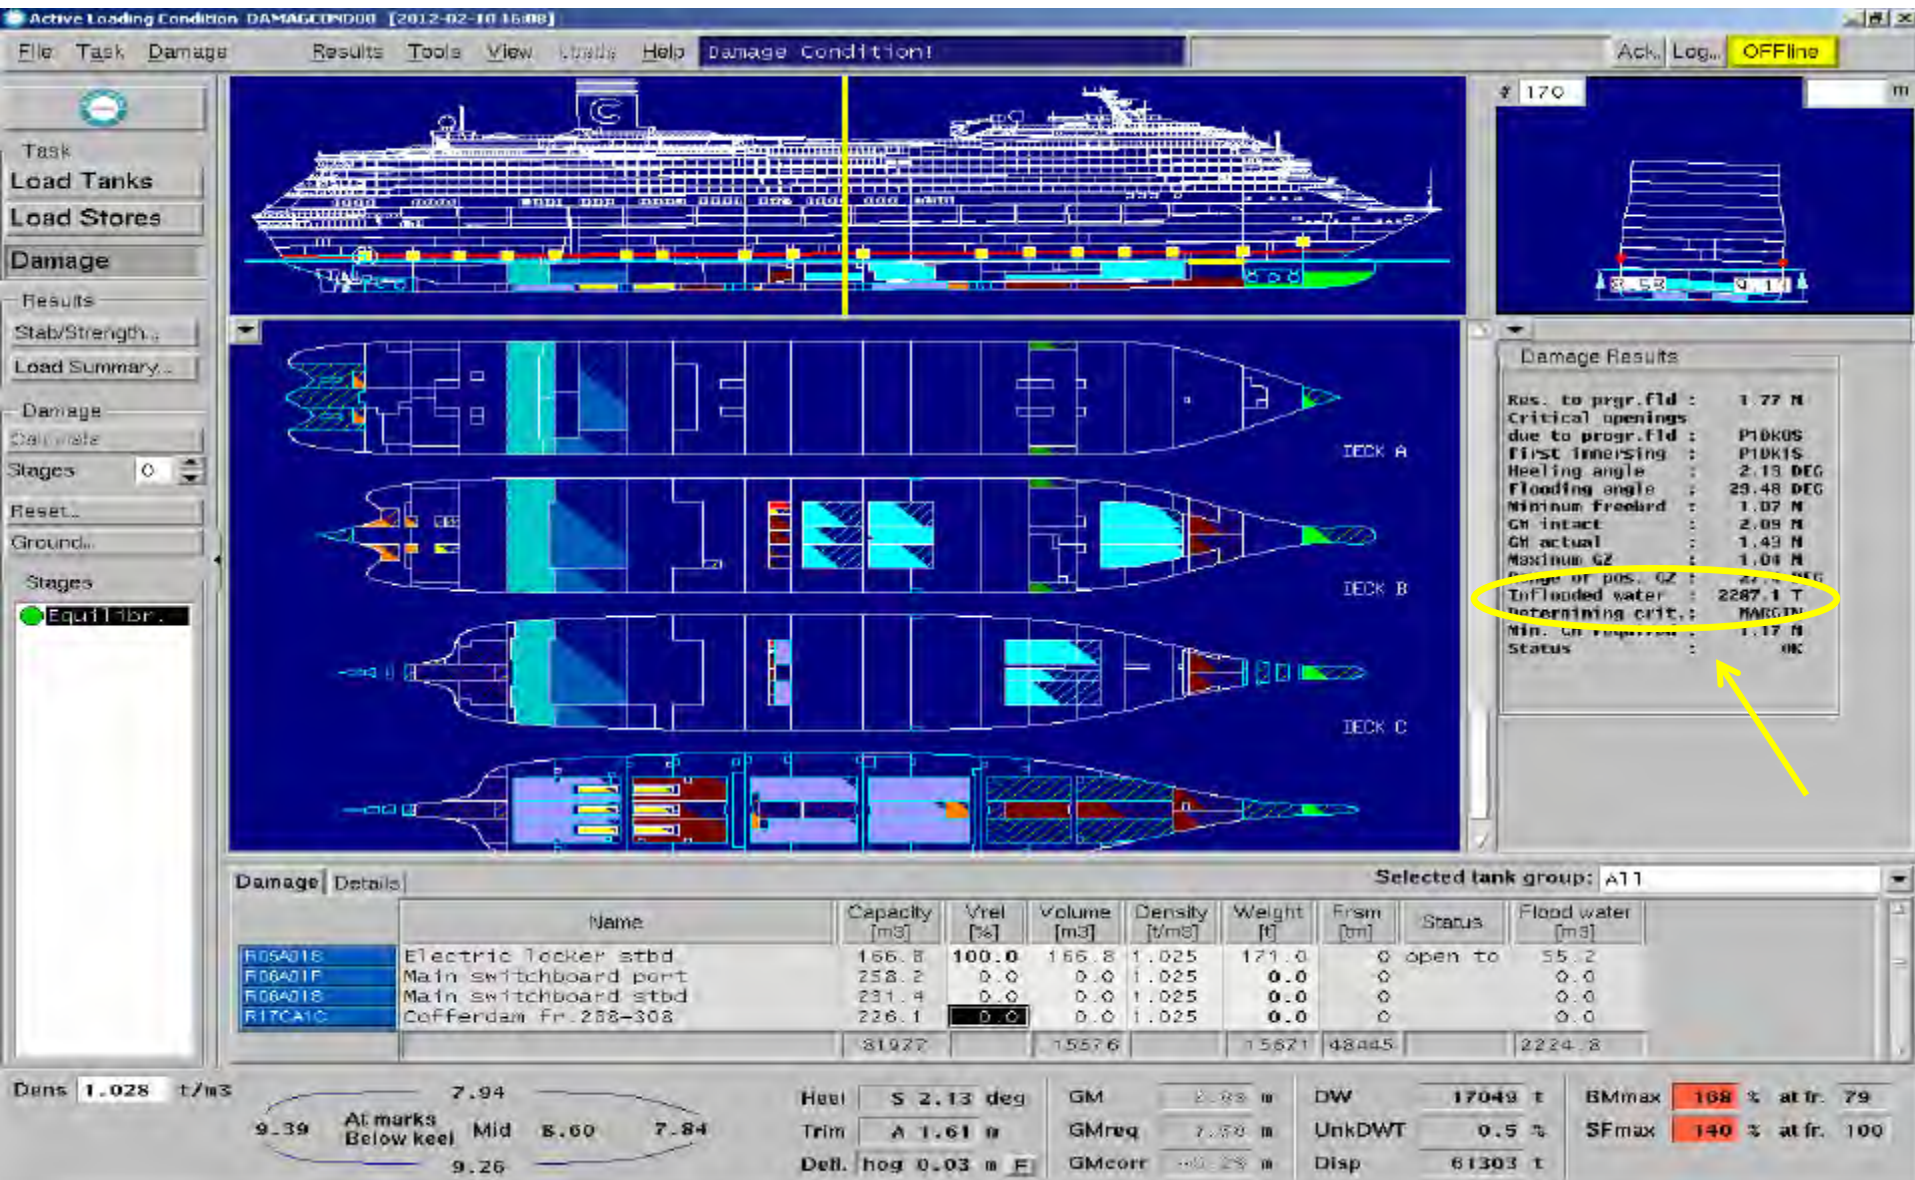
Costa Serena simulation after the impact – Damage condition 0

Compartment no. 5 flooded immediately 2287.1 t of water

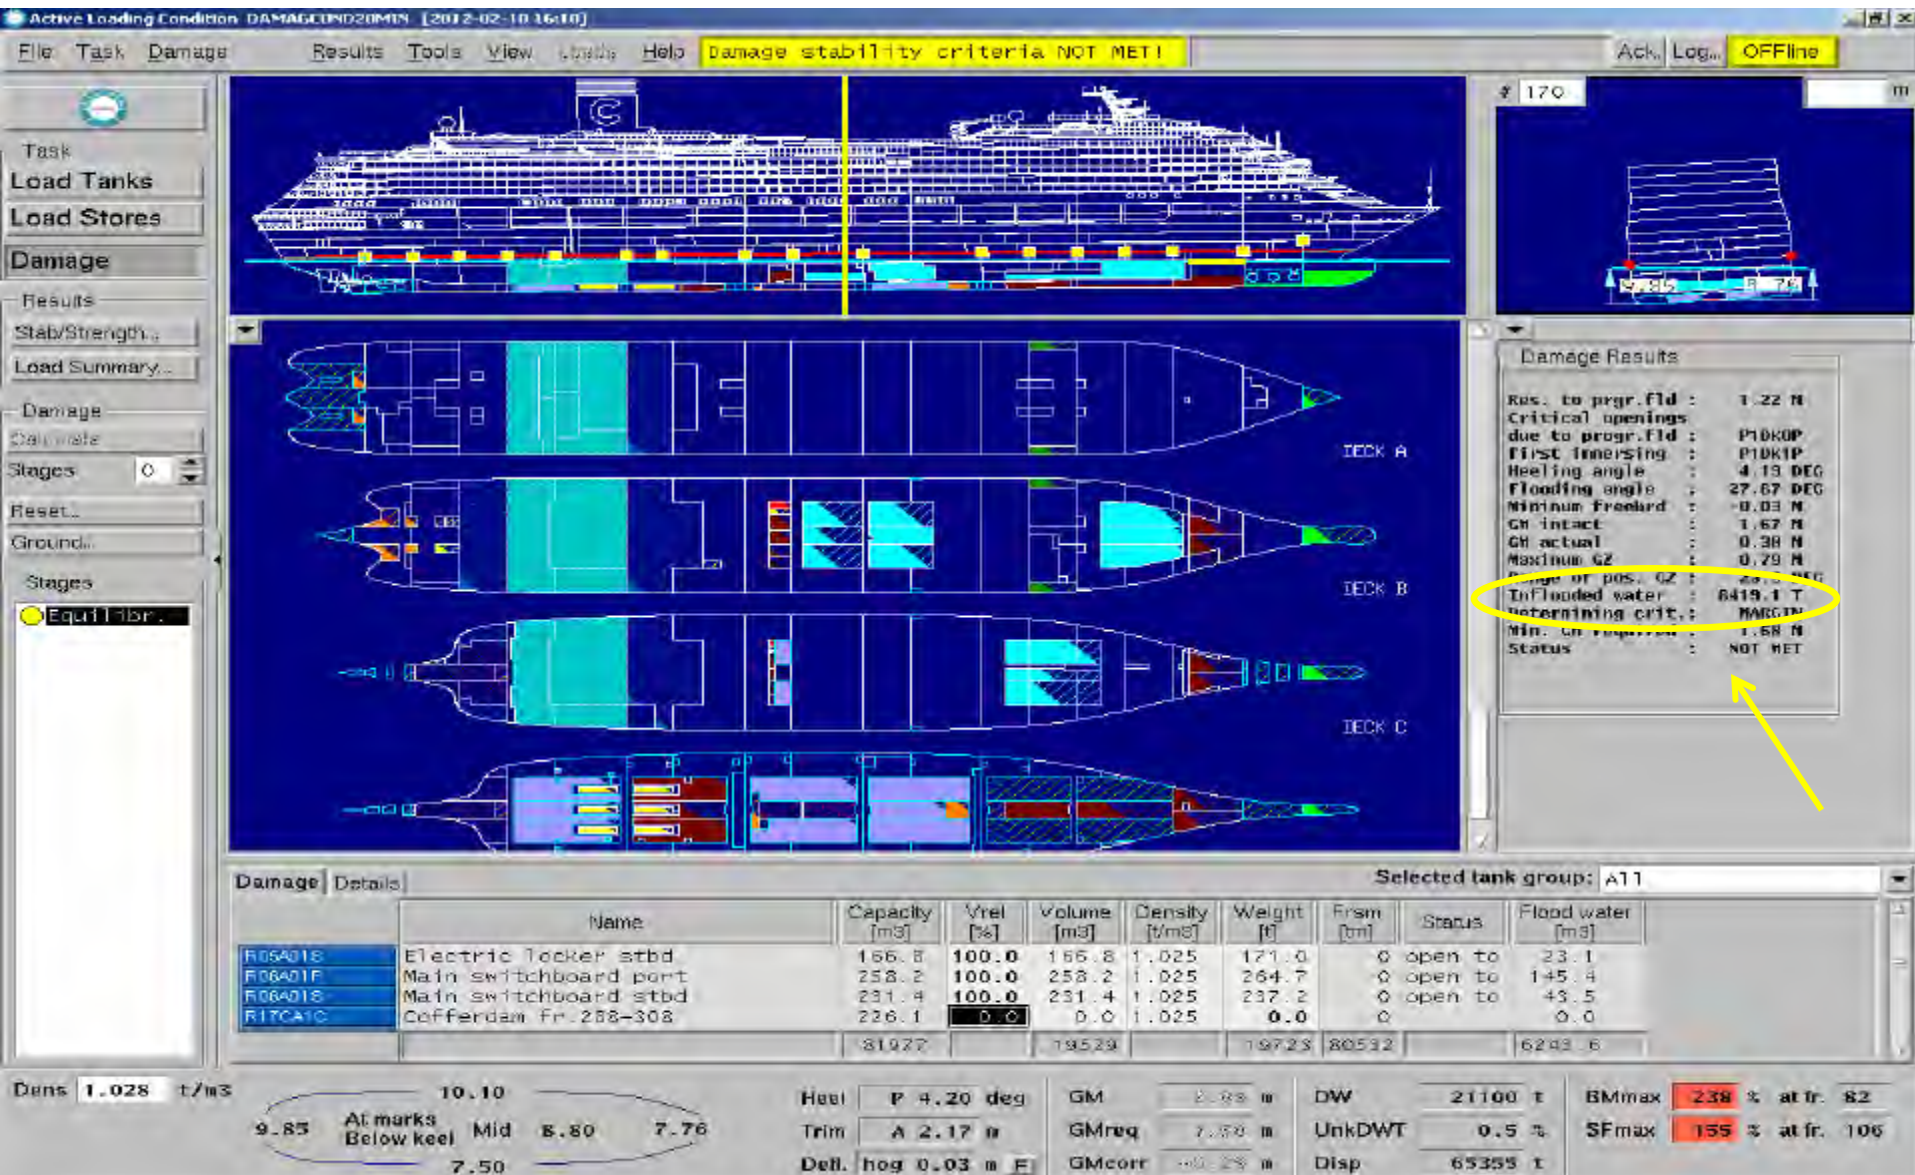
Damage condition after 20 minutes inflowing water 6419.1 t

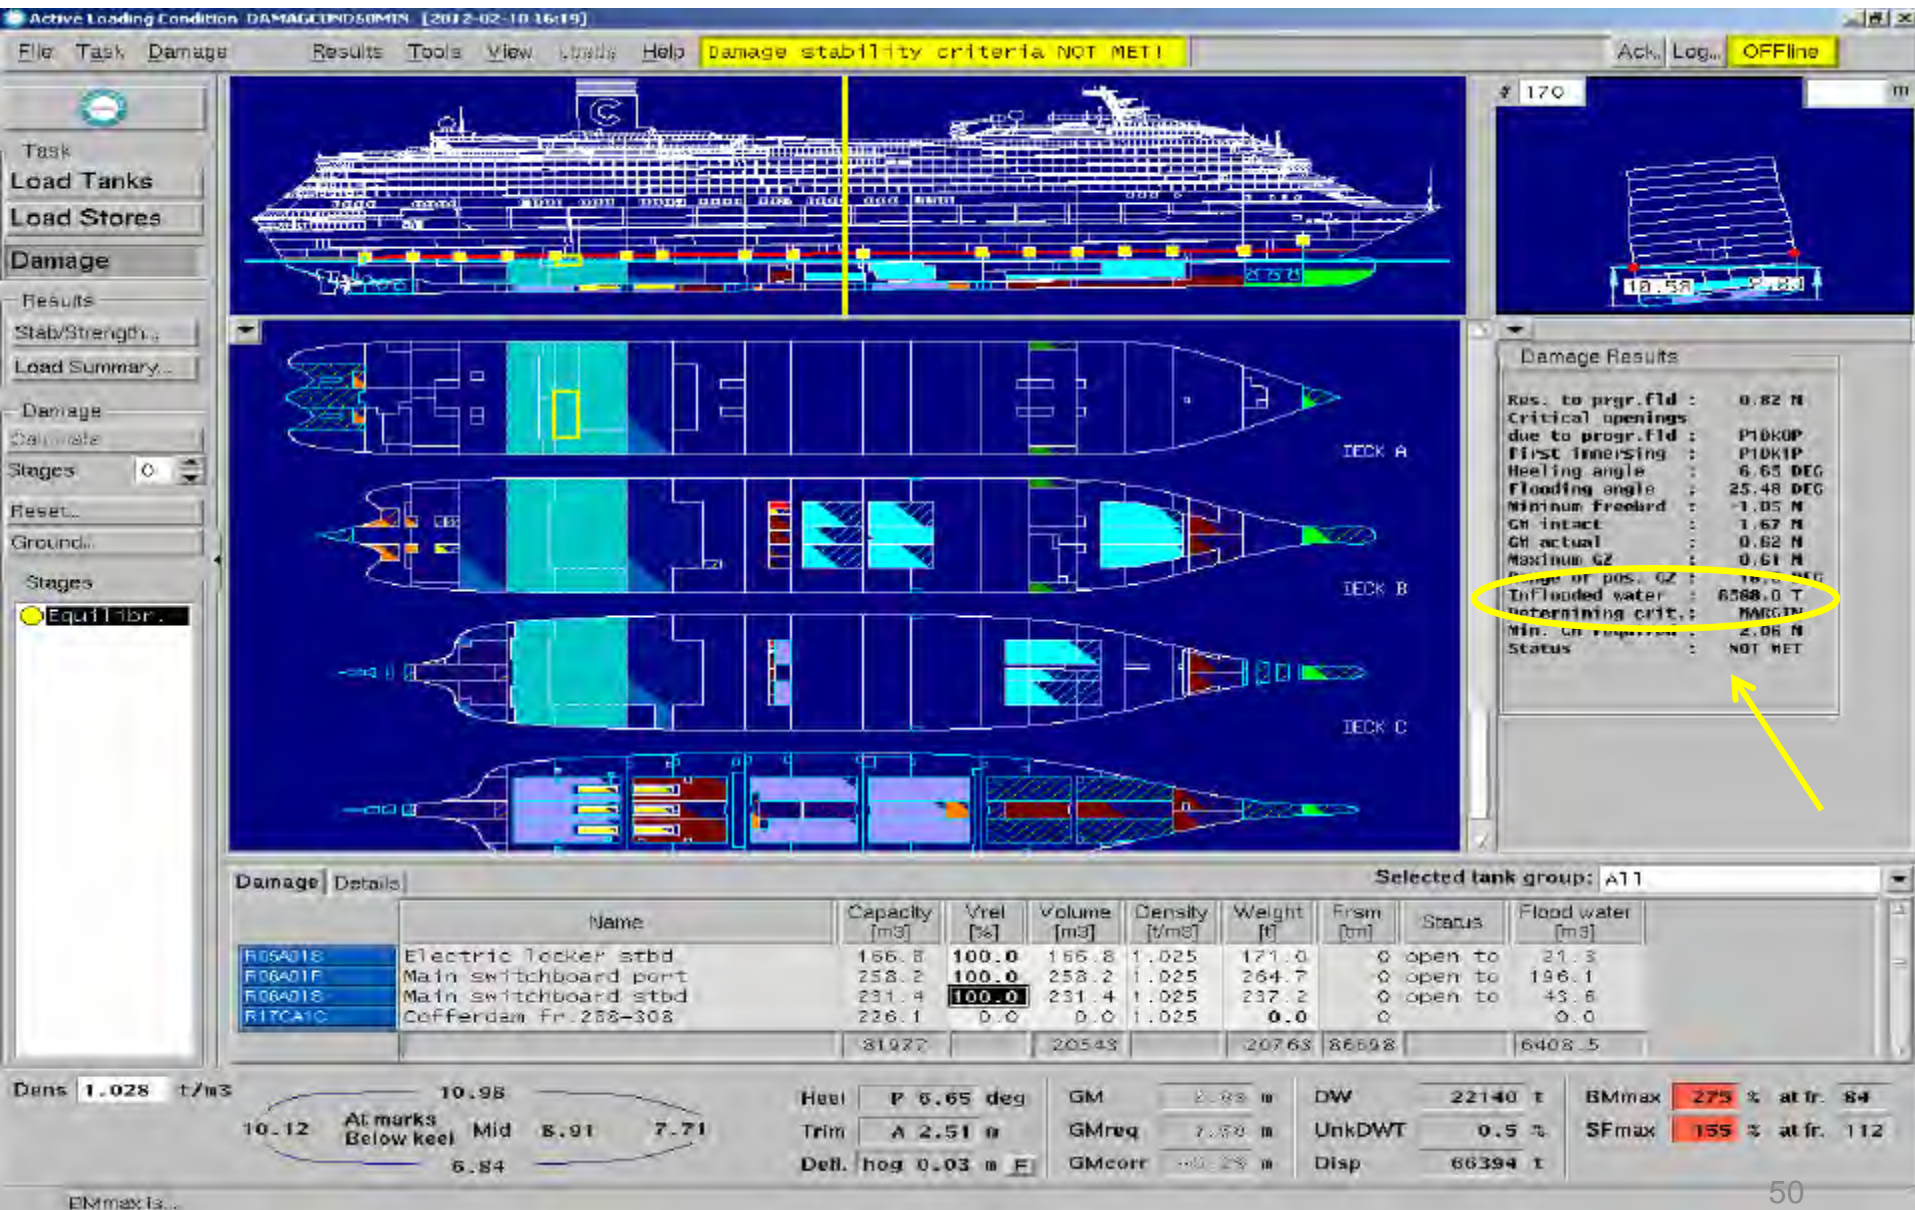
Damage condition after 50 minutes inflowed water 6588.0 t

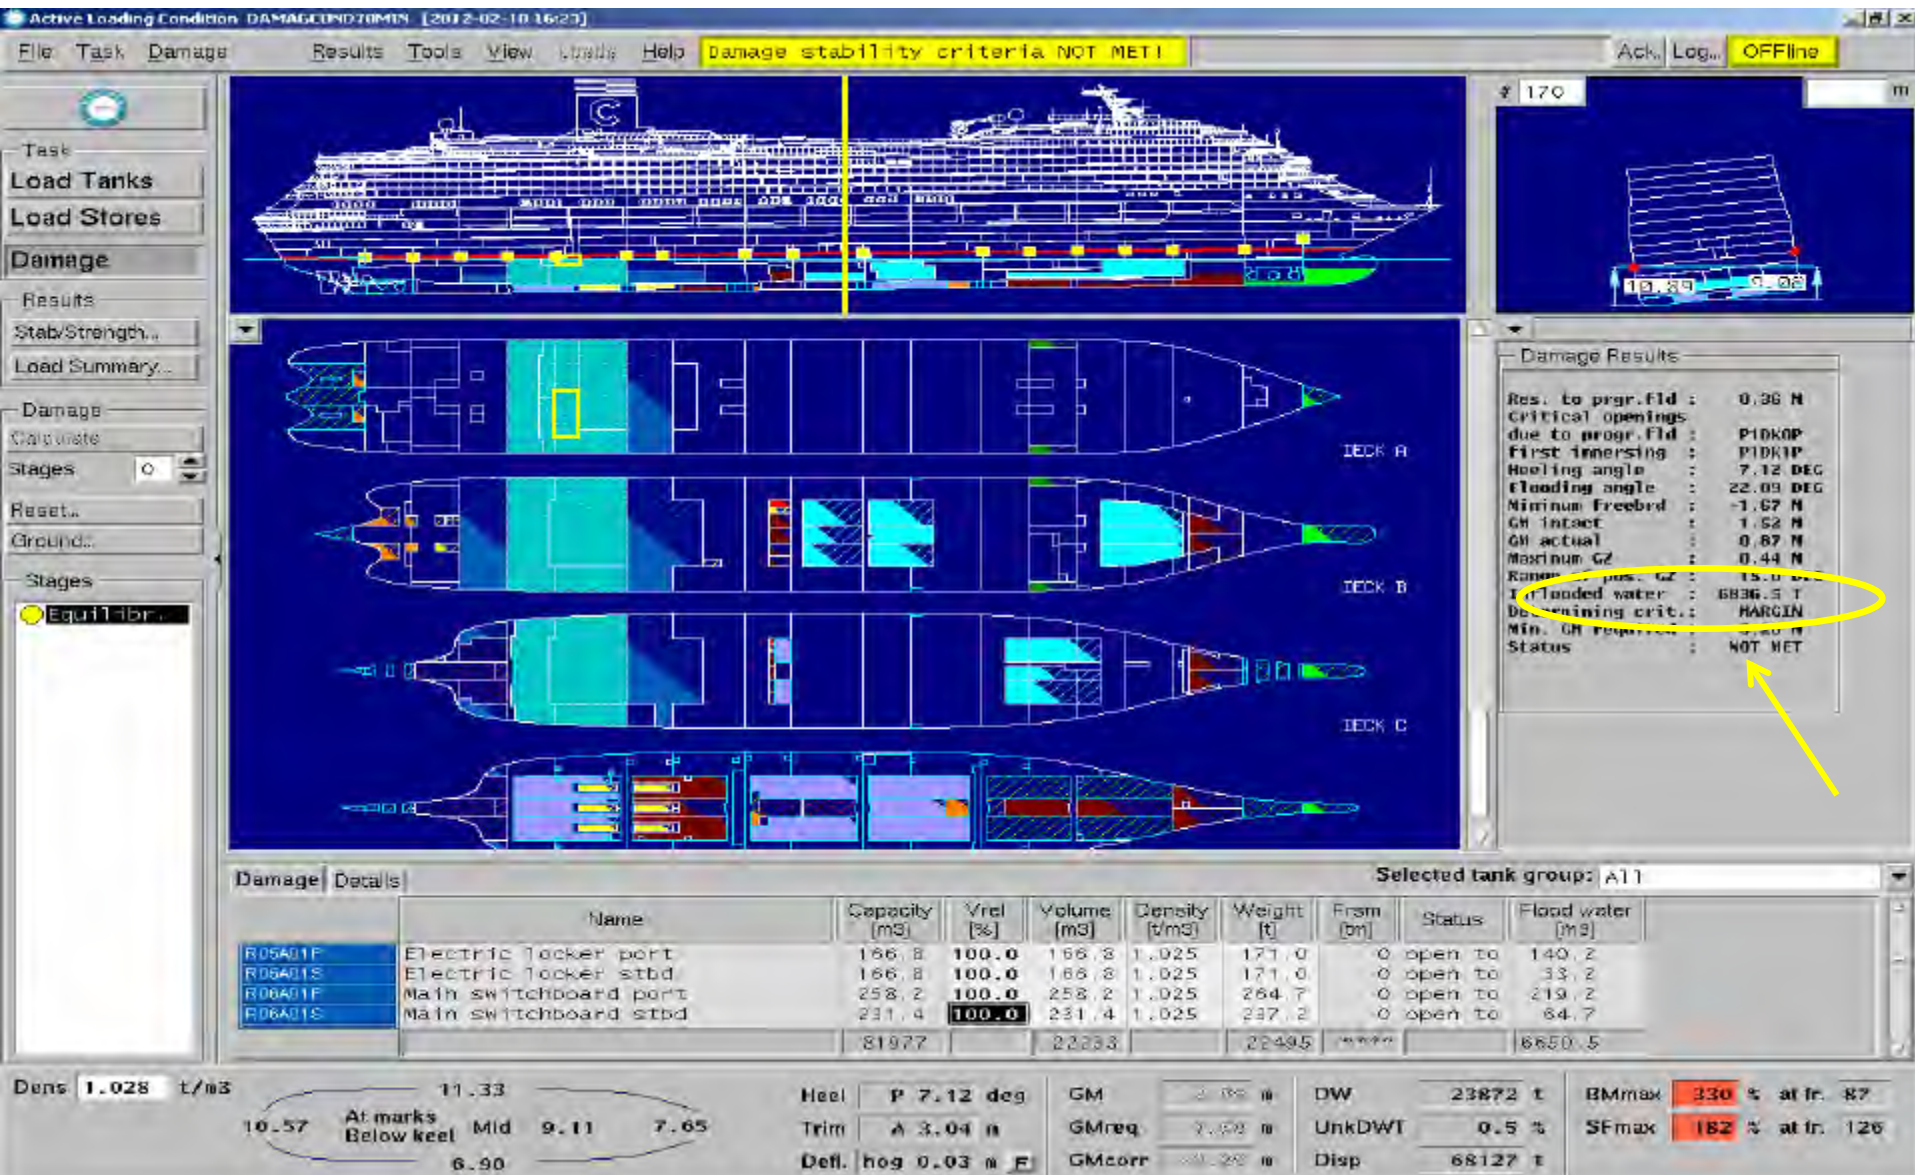
Damage condition after 70 minutes inflowed water 6836.5 t

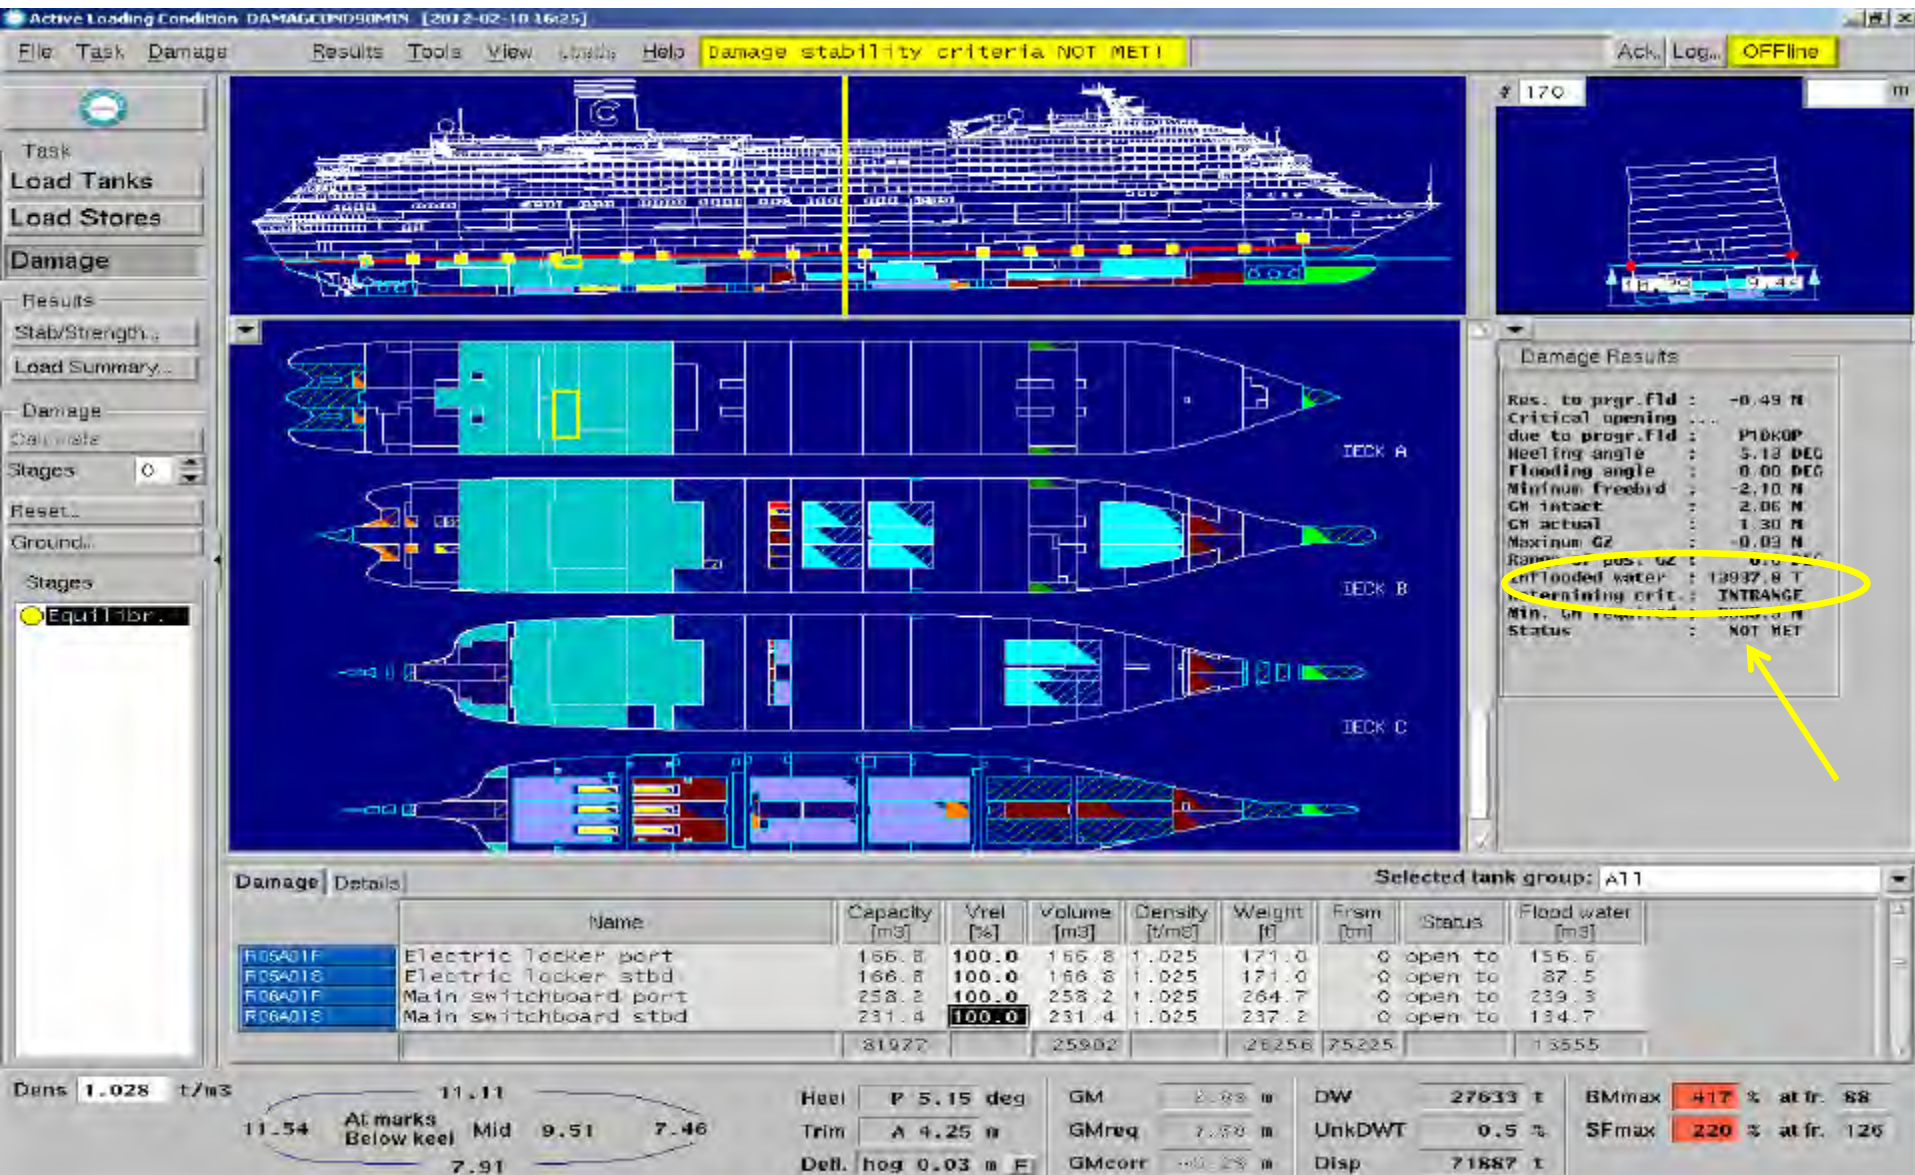
Damage condition after 90 minutes inflowed water 13937.8 t

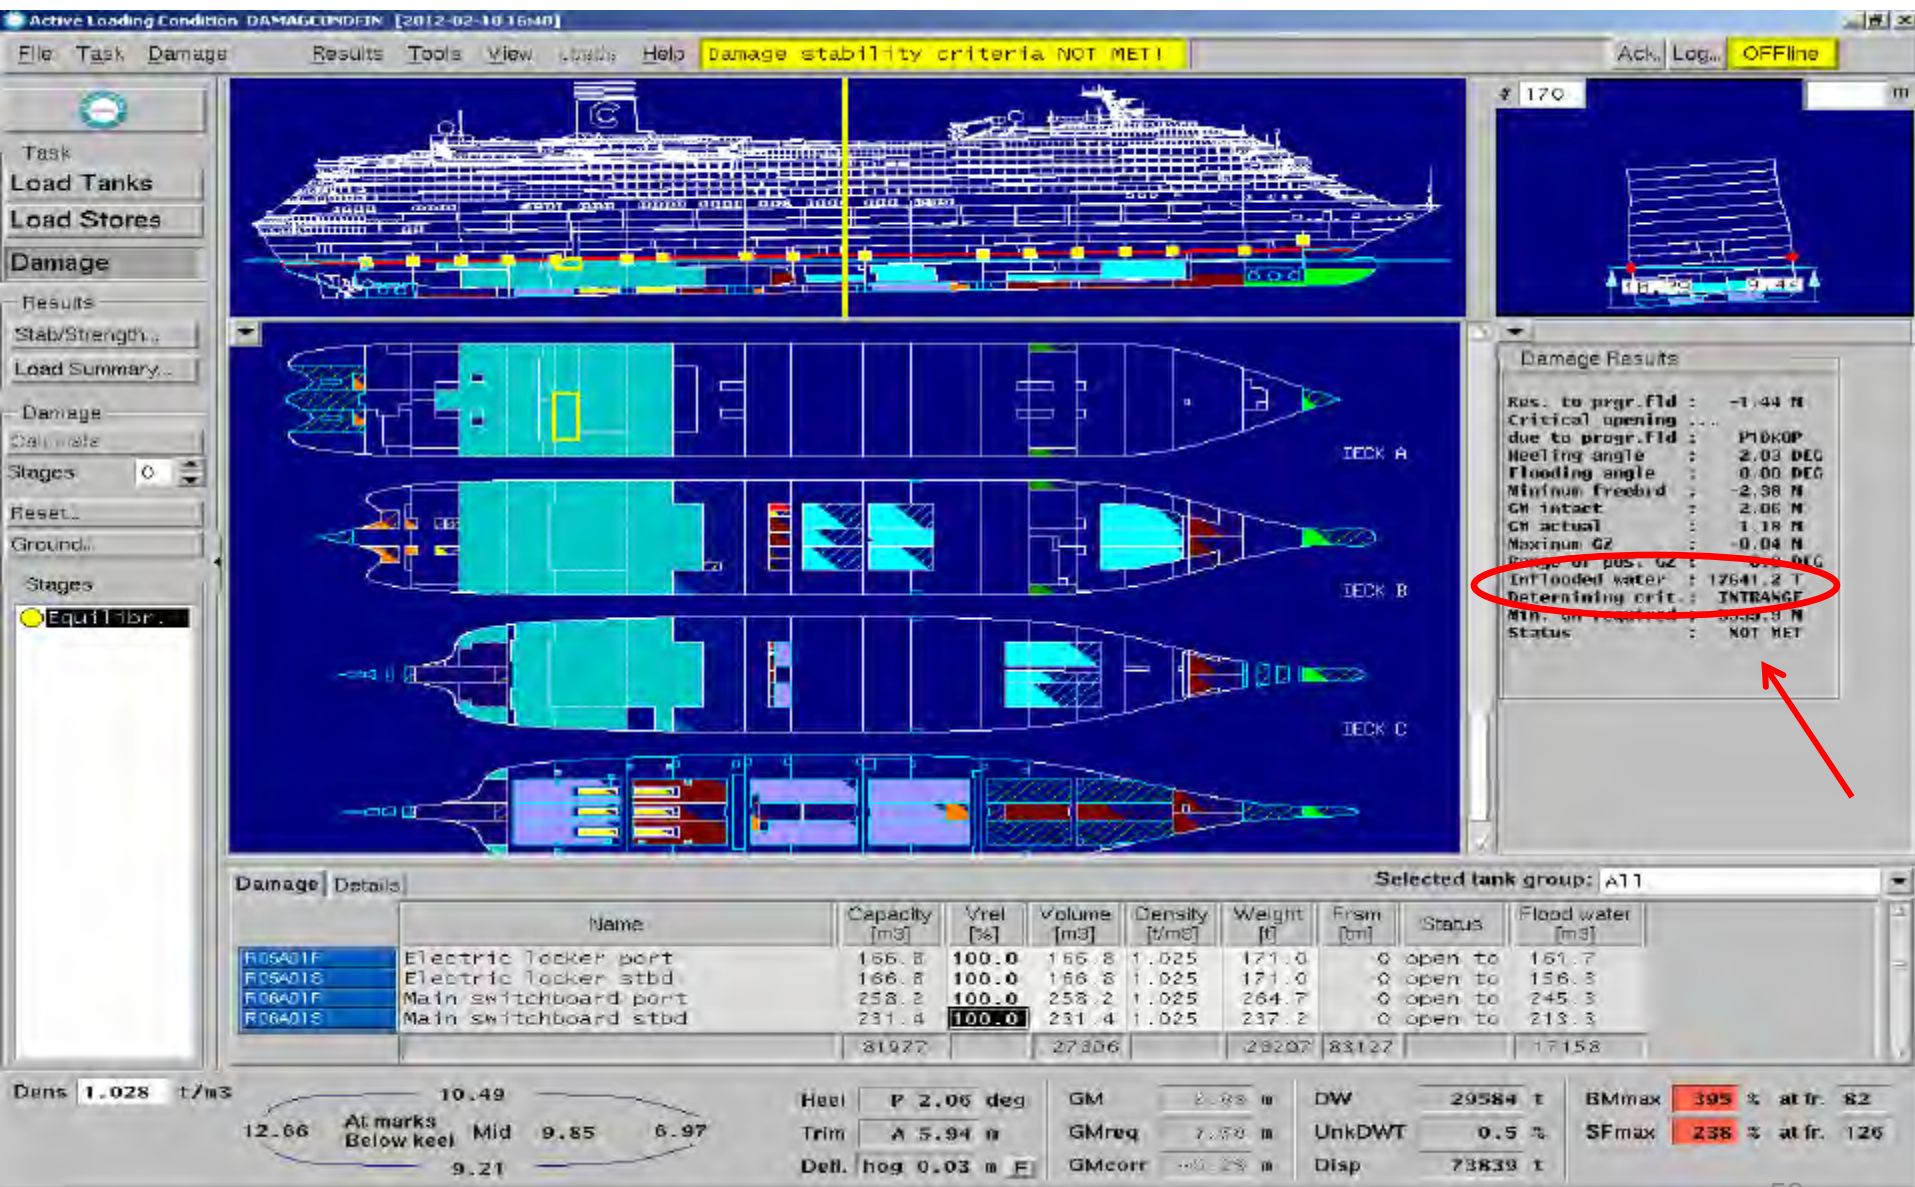
Damage final condition inflowd water **17641.2 t**
