ITALIAN MARITIME INVESTIGATIVE BODY ON MARINE ACCIDENTS

MARINE ACCIDENT
INVESTIGATION
C/S COSTA CONCORDIA
13th January 2012

*MSC90
London - May 18th, 2012*

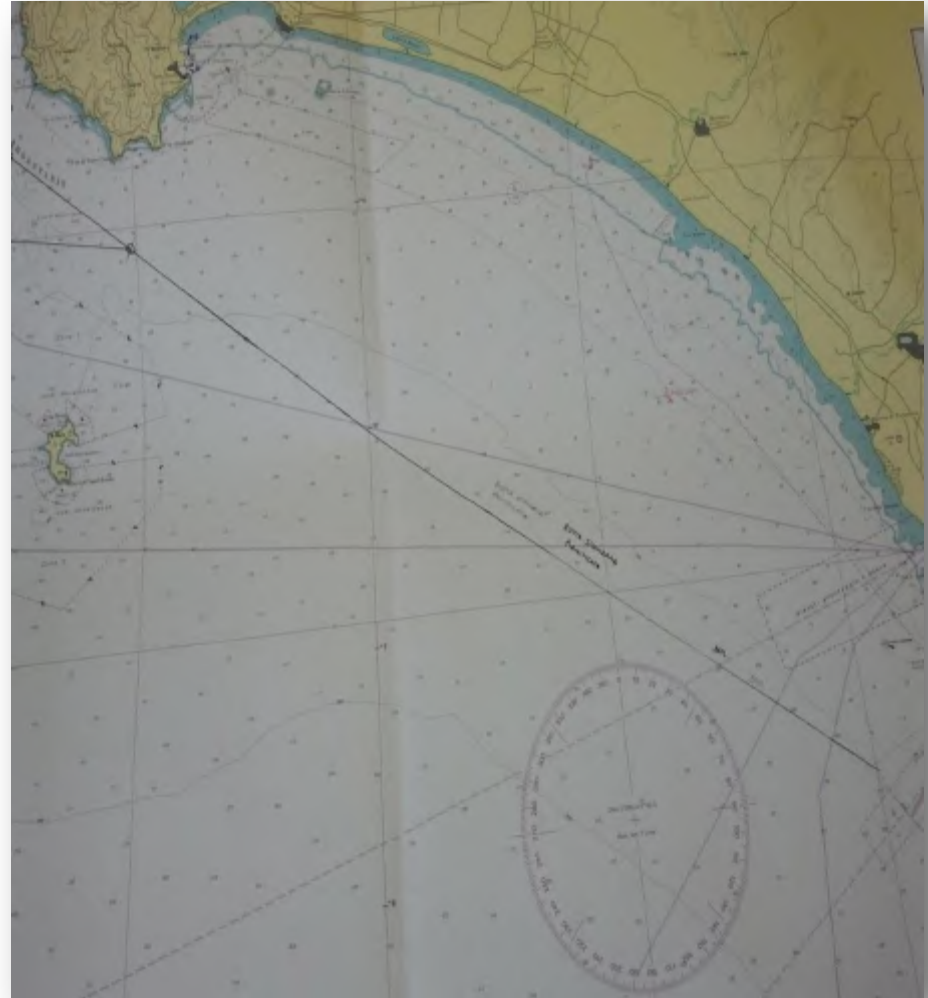
- ☐ leaving the funnel-shaped exit of the Port of Civitavecchia
- ☐ proceeding 302°
- ☐ turning to 278° - abeam *Punta Secca* (Island of Giannutri), at a distance of 4,5 miles from it
- ☐ altering the course to 334° , where *Punta della Torricella* (Island of Giglio) is bearing 239° from the ship, at a distance of 0,9 miles.

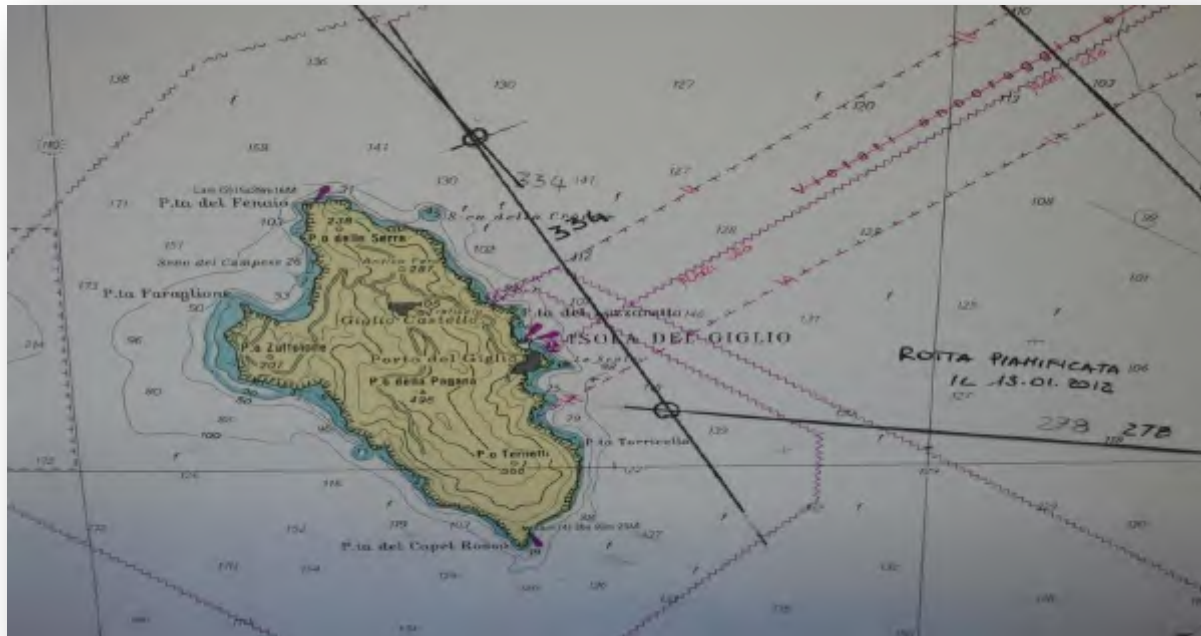
Passage 0,5 miles from the bathymetric limit of 10 meters depth, abeam “Le Scole Reef” (Island of Giglio).

The Ship's **Integrated Navigation System** (Nautical Chart nr. 6 - scale 1:100.000 of Italian Hydrographic Service and the Electronic Cartography – ECDIS) reports the planned course.

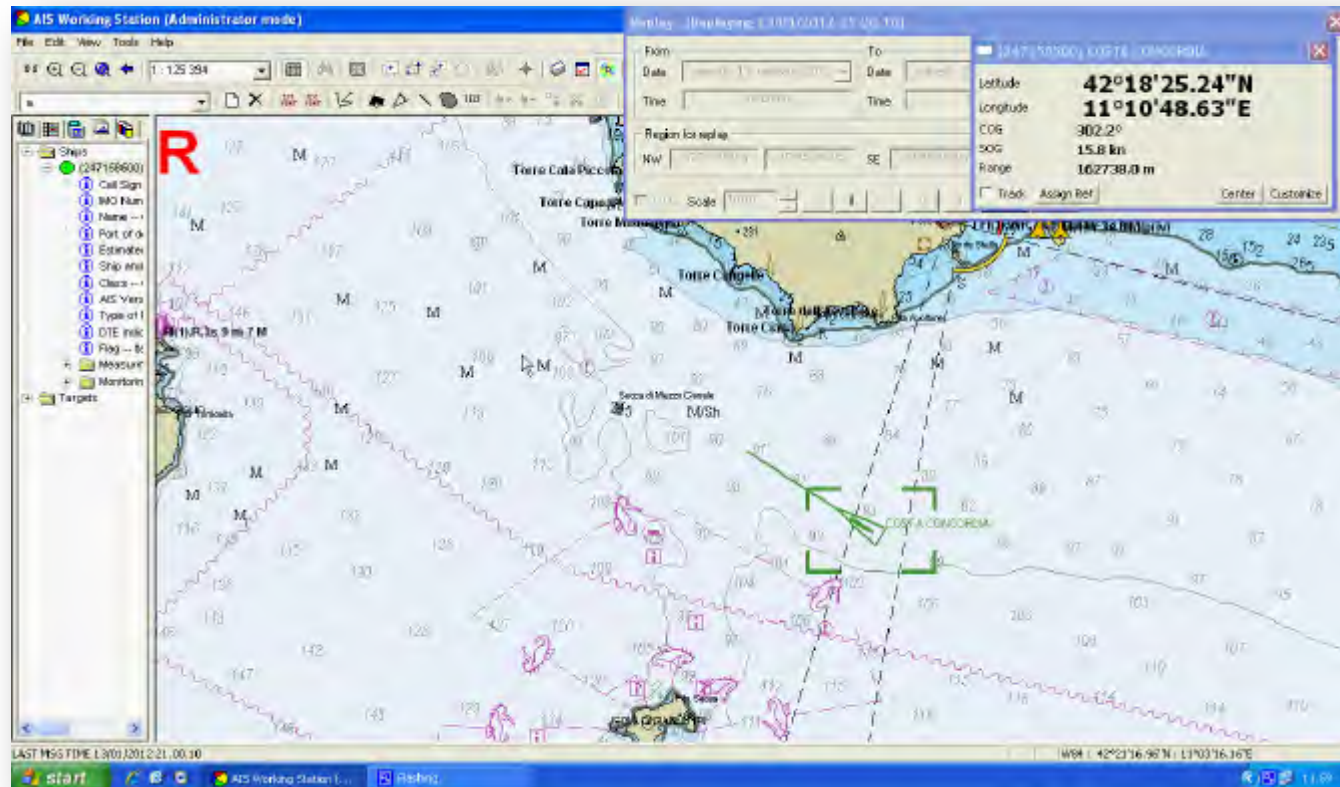
Ship's position at 09.00 pm according to the *Automatic Identification System (AIS)*

- Coordinates: Lat 42°18'25"N - Lon 011°10'48"E
- Bearing of 230° Punta Secca - Island of Giannutri
- Distance: 4,2 miles
- True course: 302°
- Speed: 15.8 knots

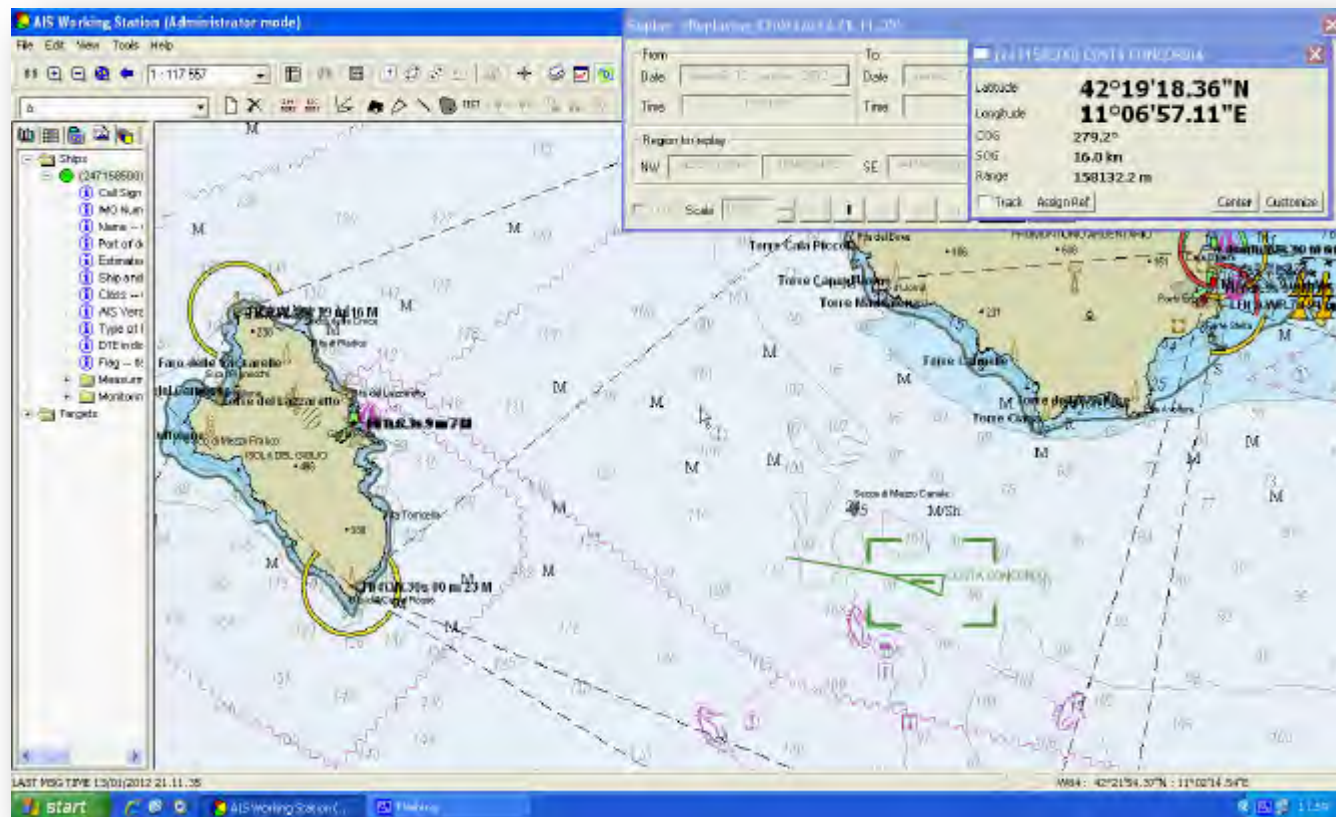
the Ship starts attending to port until 09.11 pm, when she gets to a position of

- *Coordinates:* 42°19'18"N - 011°06'57"E ;
- *Heading of* 279°,
- *Speed:* 16 knots;
- *Heading towards the Island of Giglio.*

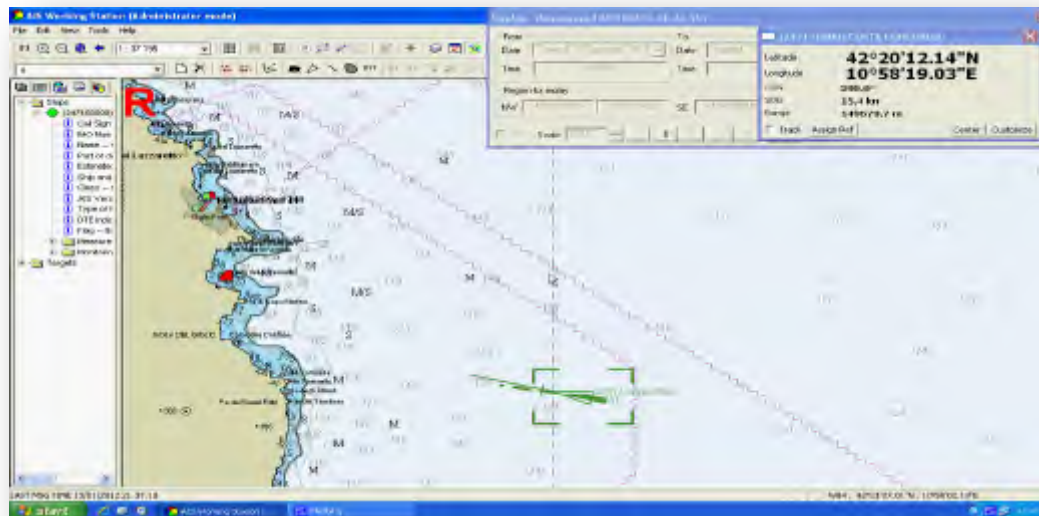
At 09.37 pm : Ship's position is $42^{\circ}20'12''\text{N}$; $010^{\circ}58'19''\text{E}$ (about 1,8 mile East Punta della Torricella - Island of Giglio), at a speed of 15.4 knots.

She turns to starboard in order to make the safety passage close to the Island.

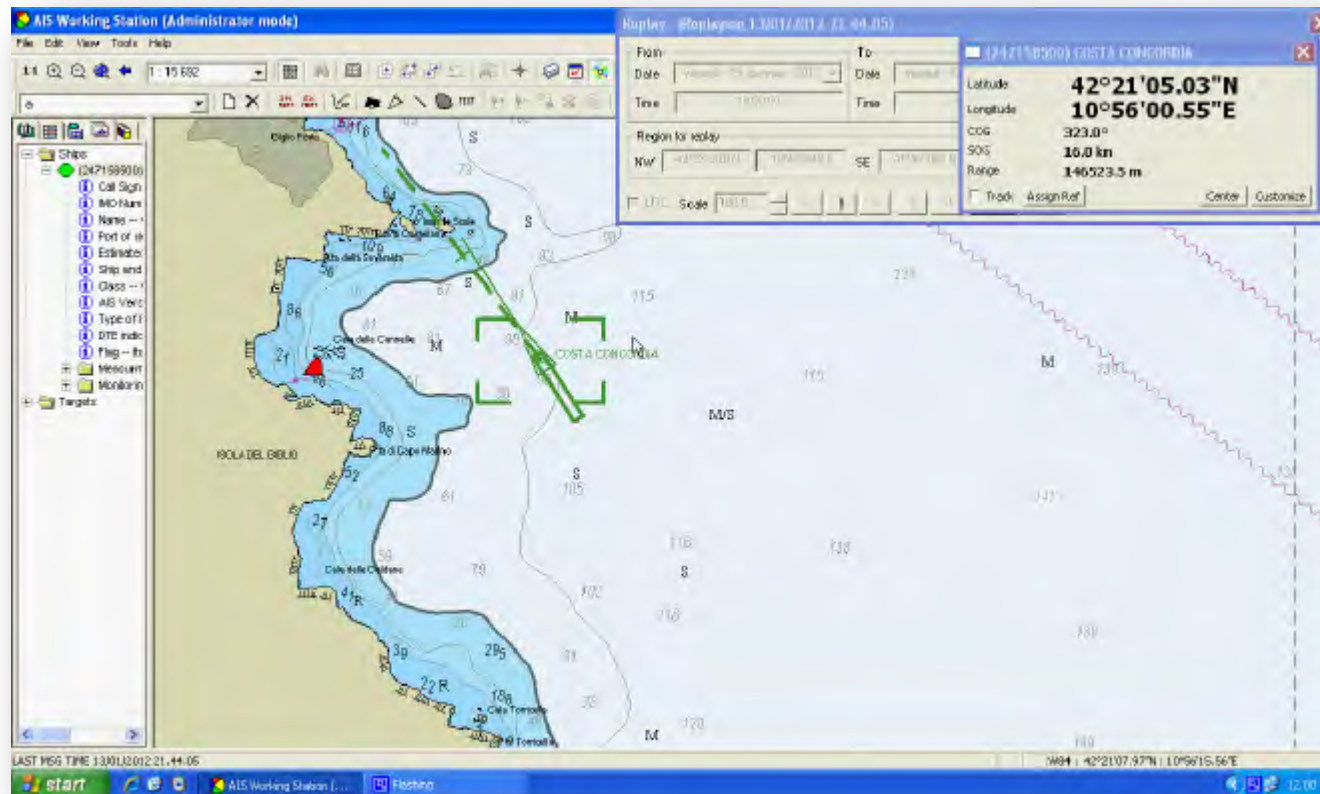
- Manoeuvre still ongoing
- Ship's position: $42^{\circ}21'05''\text{N}$; $010^{\circ}56' \text{E}$
her bow heading to "Le Scole Reef" - 0,3 miles off the rocks
- Speed: 16 knots

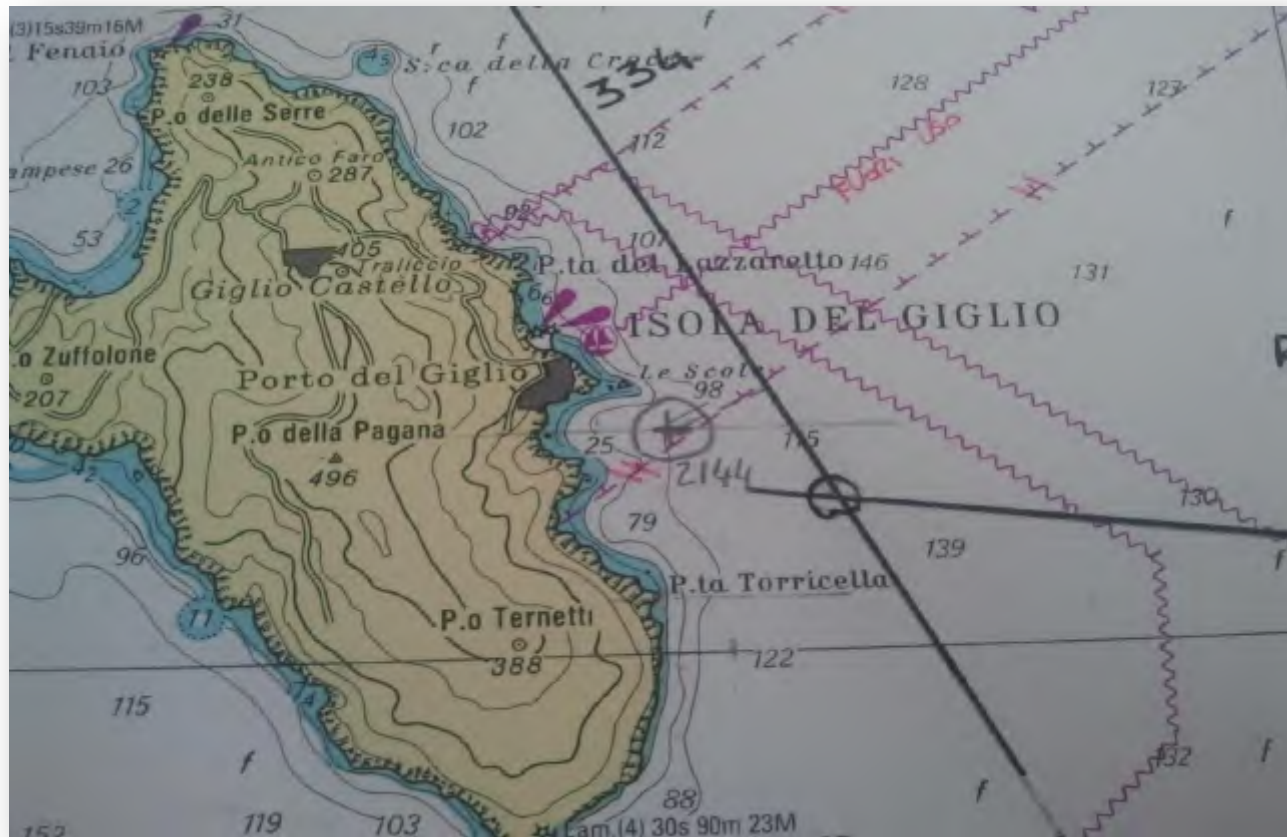
The Yaw Radius is such that the Ship is situated 0.5 miles south-west off the planned course - much more close to the coast compared to the planned route

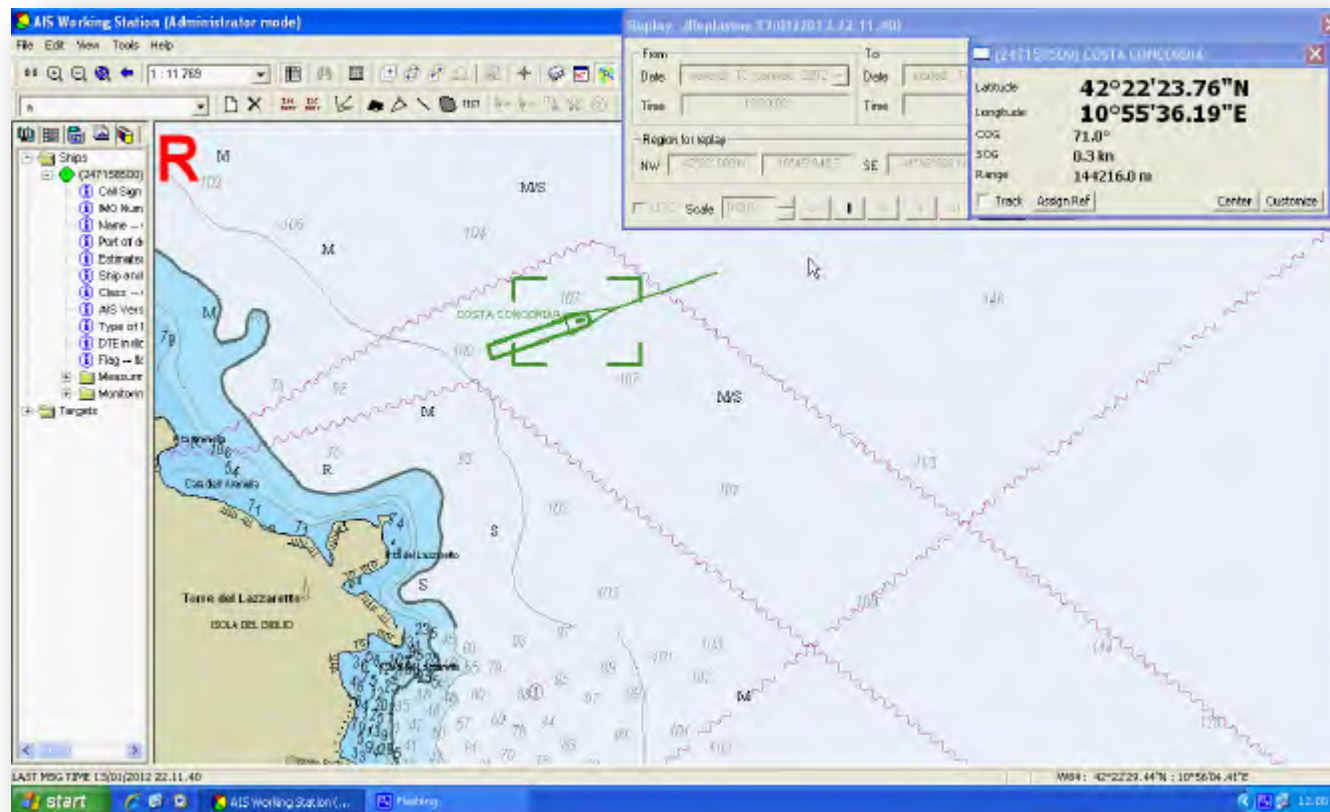
- detects the Ship in proximity of the Island of Giglio (Punta Lazzaretto).
- tries to contact the Ship. Someone onboard (unknown identity) informs about the black out onboard.

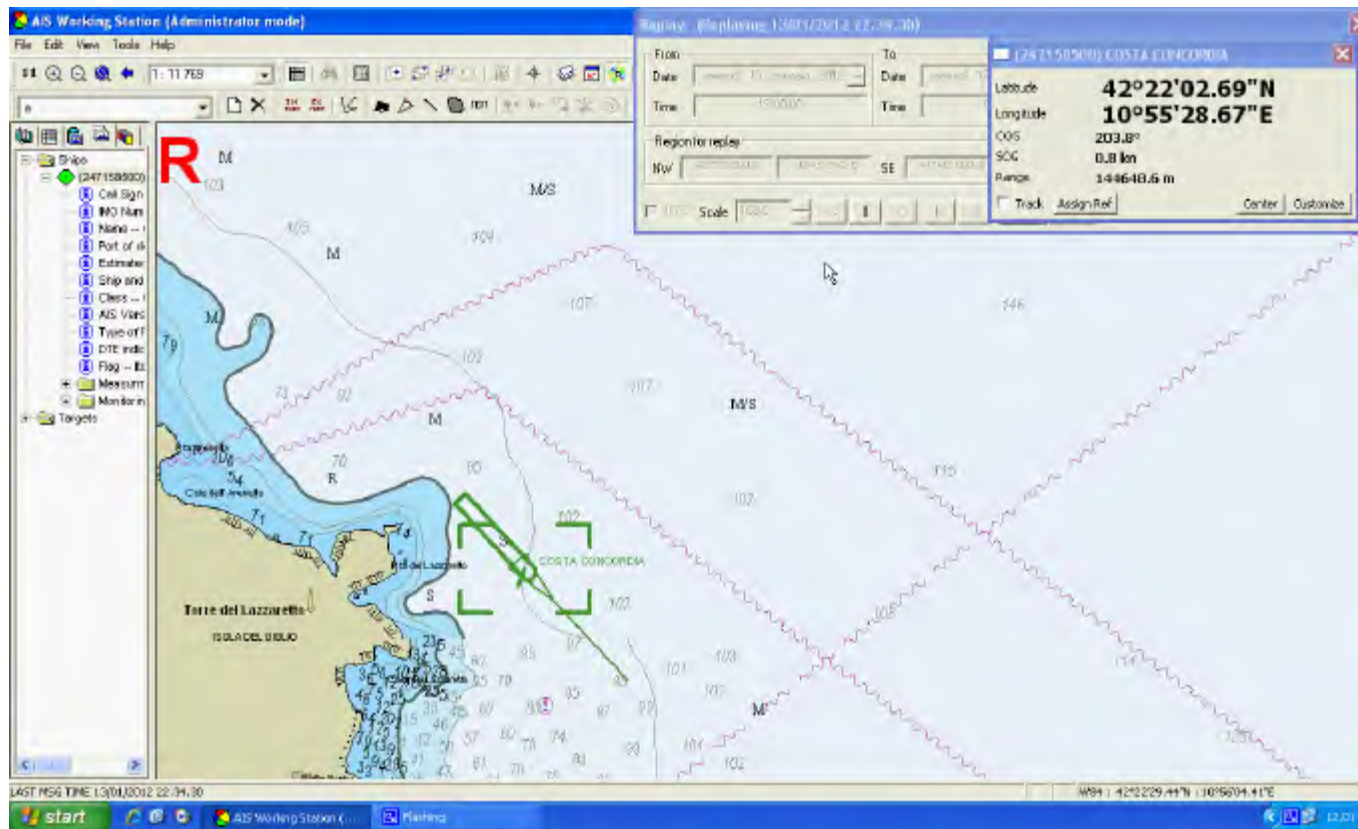
The ship reports that the heeling is increasing and declares the “**DISTRESS**”

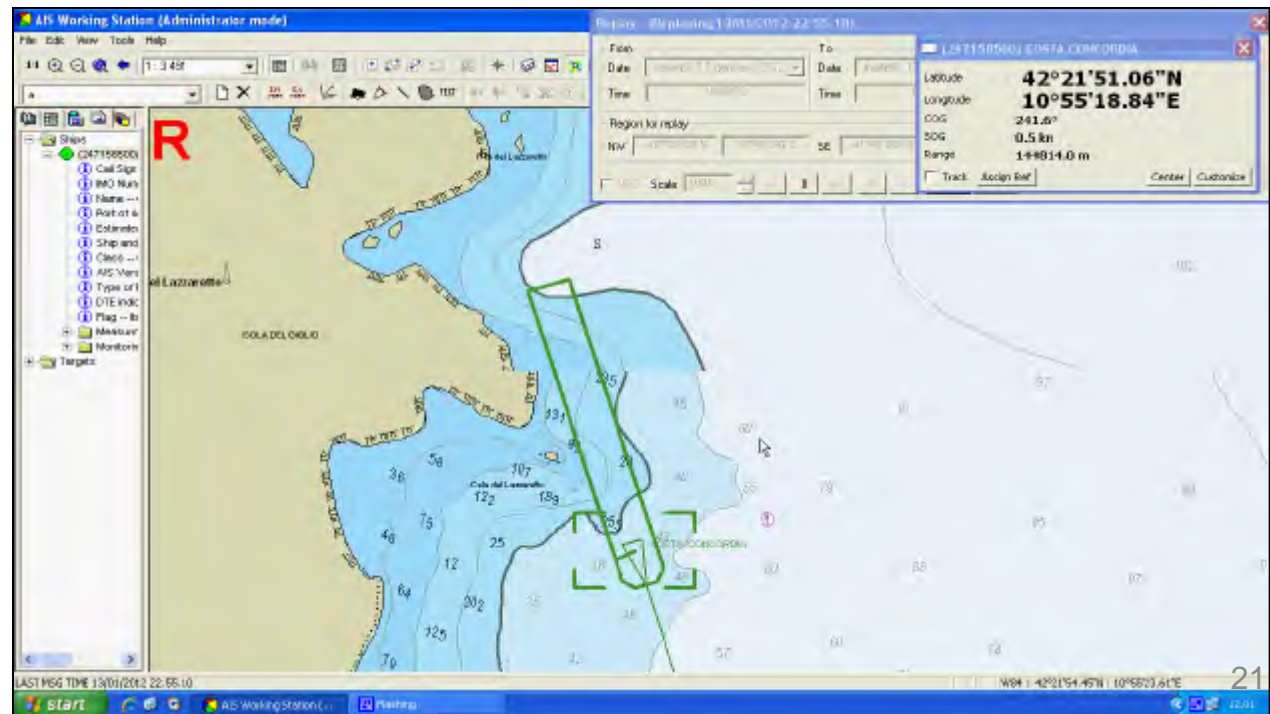
“Patrol boat G 104” (designated O.S.C. – On Scene Commander), being alongside the ship, informs Leghorn M.R.S.C. about the Ship’s stern heaviness, and at 10.44 pm she is laying on her starboard;

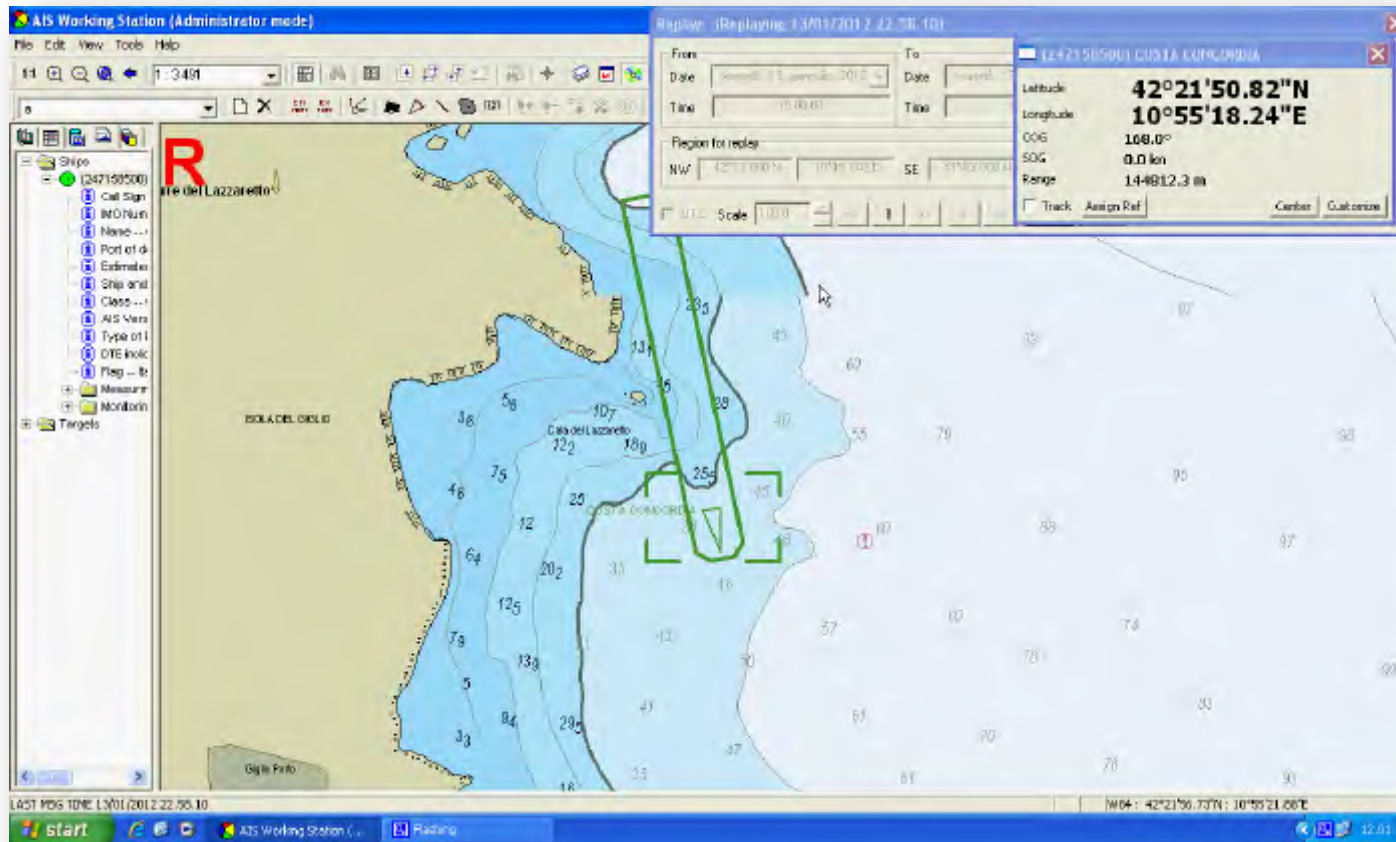
Almost in **final grounded position**, struck, Lat $42^{\circ}21'50''\text{N}$ – Lon $010^{\circ}55'18''\text{E}$
Island of Giglio – Cala del Lazzereto

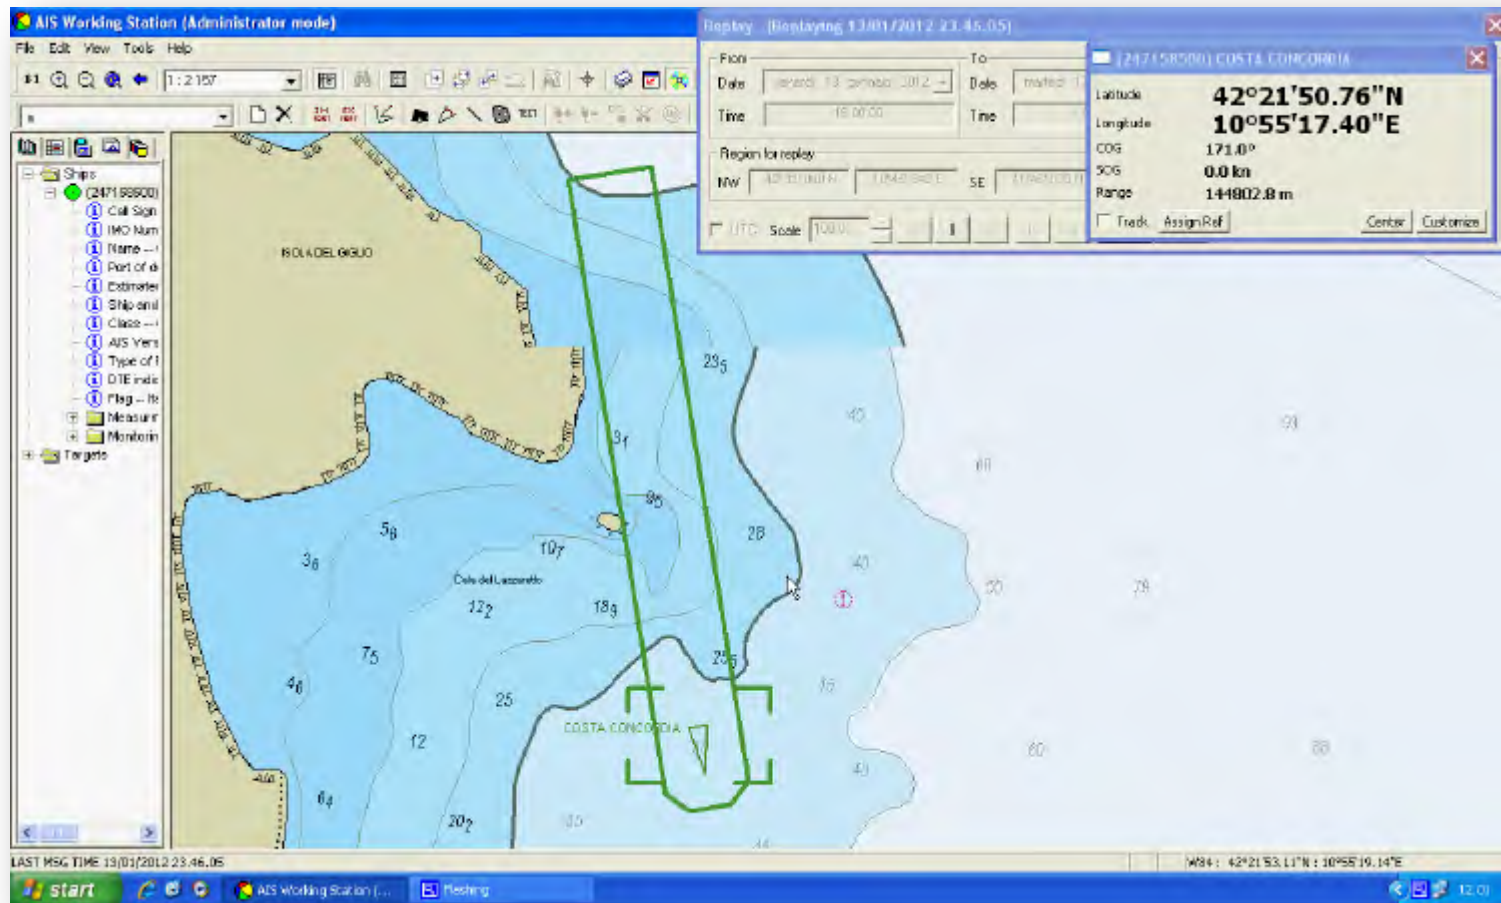
SHIP'S LAST POSITION

- **01.46 am:** Leghorn M.R.S.C intimates the Ship Master to go onboard the Ship and to give an account of the actual situation
- **03.44 am :** 40-50 persons at least are onboard
- **04.22 am :** 30 persons are still onboard
- **04.39 am:** On Leghorn M.R.S.C. request, the “Patrol boat G.104” reports the ship’s position - $42^{\circ}21'.36N$ $010^{\circ}55'.12E$, laying on a 27 meters bottom

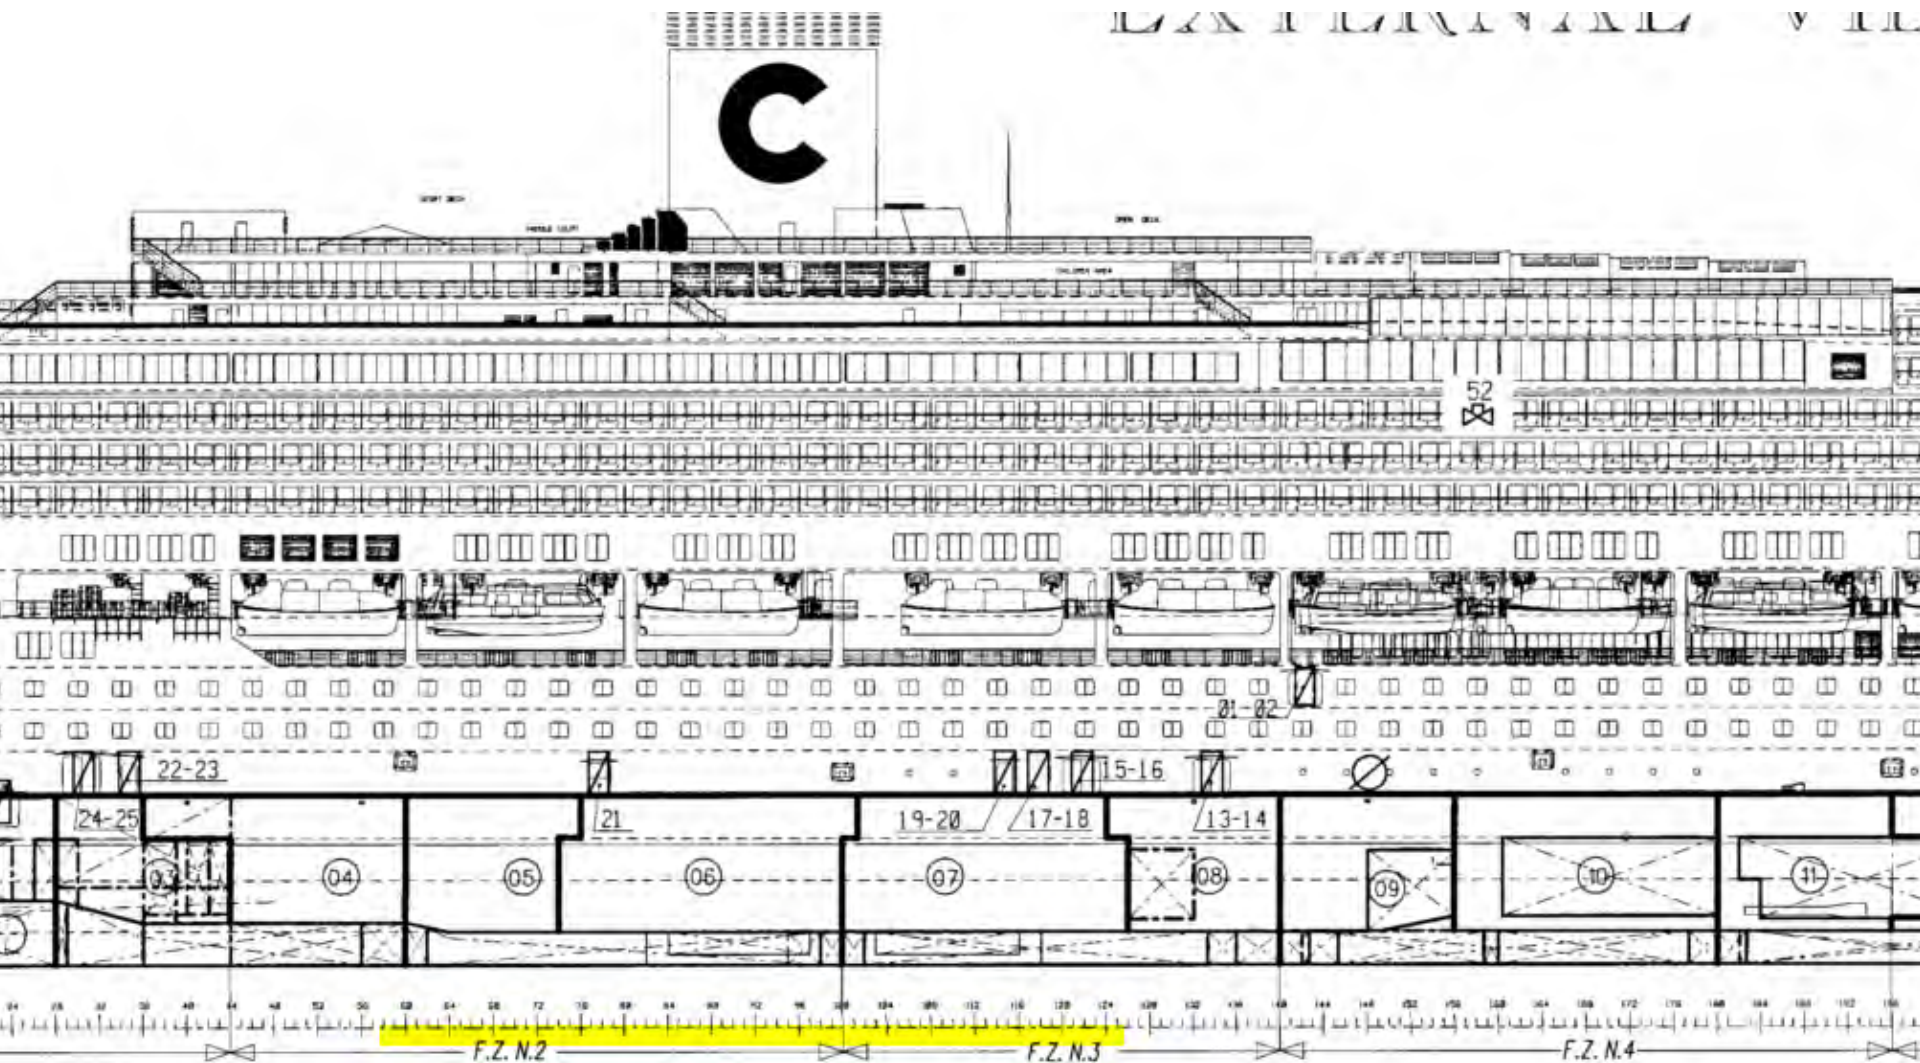
**Damage between frame no. 58 and frame no. 125/128,
creating a 60 meters hole into the hull – portside**

- The two most affected watertight compartments (contiguous), immediately flooded:
 - no. 5 (Propulsion Electric Motor)
 - no. 6 (aft generators)
- Partially flooded at the time of crew inspection (10 minutes after the impact)
 - no. 7 (forward generators)
 - no. 4 (Galley compressors)
