SUB-COMMITTEE ON CARRIAGE OF
CARGOES AND CONTAINERS
11th session
Agenda item 15

CCC 11/15
3 June 2025
Original: ENGLISH
Pre-session public release: ☒

Enclosed space fatalities aboard ships for the period 2000 to 2024

Submitted by IBTA

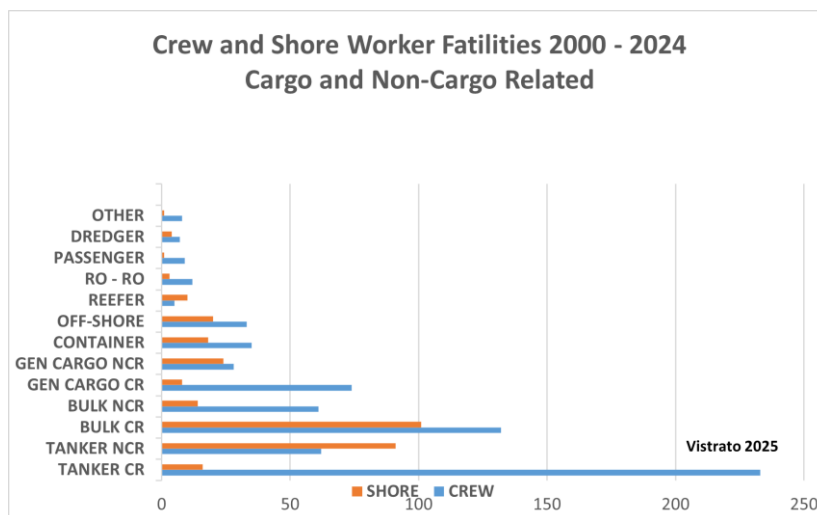
18 Of the 1,010 fatalities identified, crew members accounted for some 700 (69%), with 310 shore workers (31%) also losing their lives while working in enclosed spaces on ships.

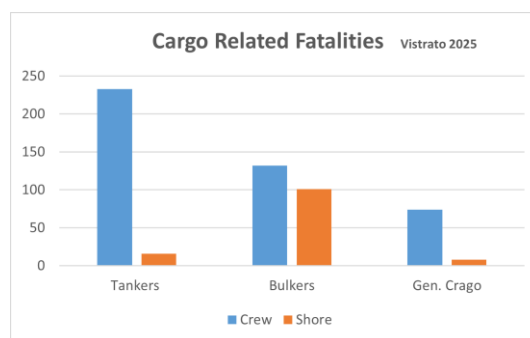
20 In total, 315 fatalities were related to solid bulk cargoes on bulk carriers and general cargo ships, of which 206 were crew and 109 were shore workers. These occurred during the shipping of cargoes subject to the IMSBC Code, its predecessor the BC Code, and the Grain Code, and amounted to 31% of all enclosed space fatalities on ships since 2000.

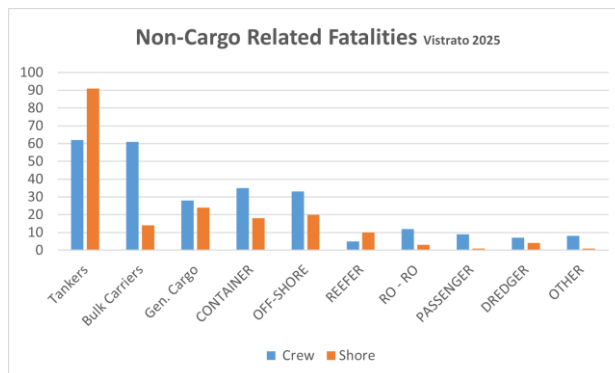
22 Some 446 deaths (44%) were non-cargo-related, with 280 occurring on tankers, bulk carriers and general cargo ships. The remaining 166 were on all other ship types:

- Tankers: 153 (62 crew / 91 shore)
- Bulk carriers: 75 (61 crew / 14 shore)
- General cargo: 52 (28 / 24)
- Container: (35 / 18)
- Offshore: (33 / 20)
- Ro-Ro: (12 / 3)
- Reefer: (5 / 10)
- Passenger: (9 / 1)
- Dredgers: (7 / 4)
- Others: (8 / 1).

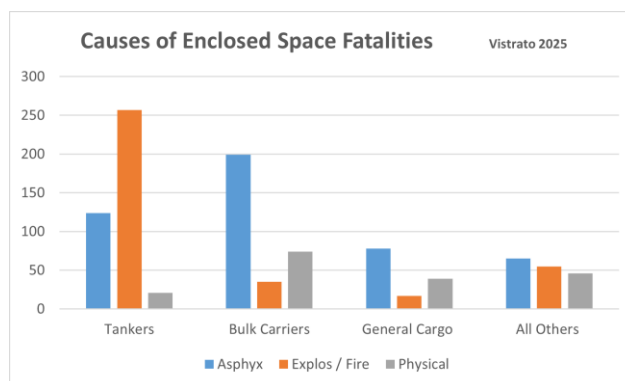
24 It was found that 466 (46%) of all fatalities were caused by asphyxiation due to oxygen depletion and/or toxic gas poisoning. A total of 364 (36%) were due to explosion and/or fire and 180 (18%) were due to physical hazards in the space. Over 50% of those were due to falls.

25 Explosions and fires caused by flammable atmospheres were the main causes of the 402 enclosed space fatalities on tankers (64%) followed by asphyxiation/toxic gas (31%) and physical hazards (5%).

26 Asphyxiation/toxic gas was the biggest cause of the 308 deaths on bulk carriers (65%), followed by physical hazards (24%) and explosion/fire (11%). Asphyxiation/toxic gas was also the biggest cause of the 300 deaths on all other ship types (48%), followed by physical hazards (28%) and explosion/fire (24%).
